### COFFEY GEOTECHNICAL ROCKFALL REPORT

Site specific to 23K Walkers Road, Lyttelton.

26 November 2014

## **ROCKFALL ASSESSMENT OF THE OAKLEY PROPERTY AT 23K WALKERS ROAD, LYTTELTON, CHRISTCHURCH**

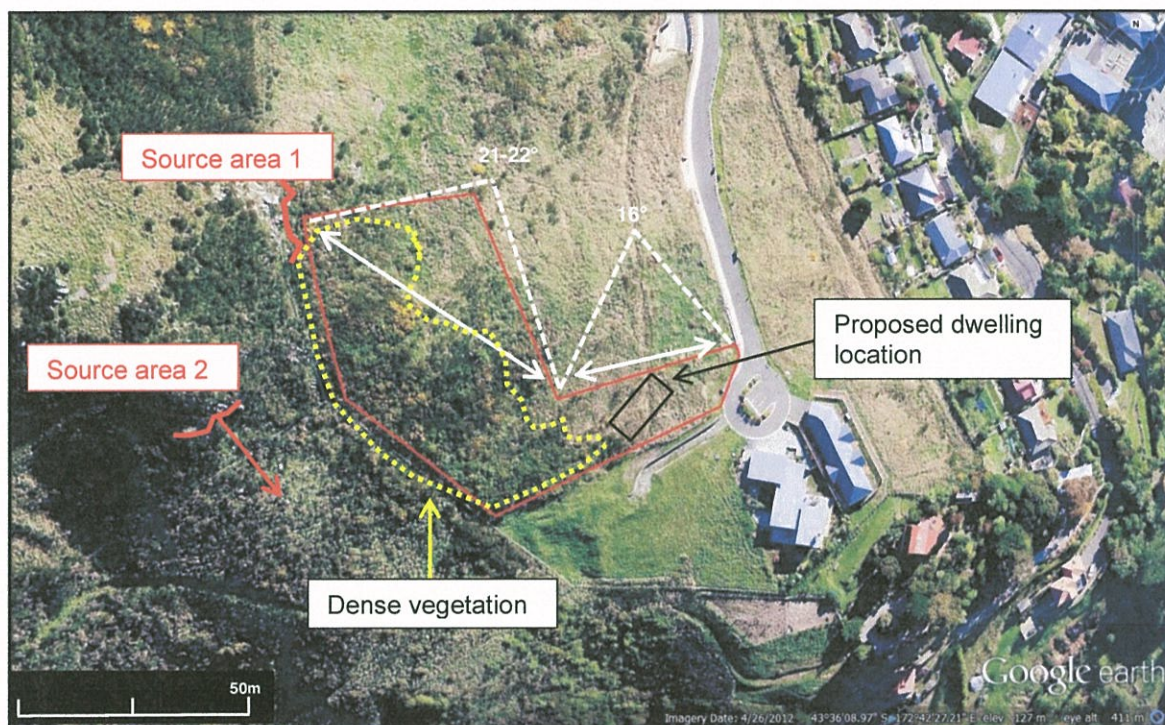
Figure 2: Site observations summary (scale as shown)<sup>5</sup>

The most pertinent observations from the site walkover are summarised below and are displayed in Figure 2:

- There were no observed boulders in the residential zone.
- The slope angle of the residential zone was approximately 16° (rising to the west).
- The partially excavated proposed building platform had evidence of the trial pits from the Bell geotechnical investigation.
- There was a small rock outcrop (source area 1) at the crest of the slope at the very edge of the rural zone of the site.
- Slope angle and vegetation density increased in the rural zone of the site (rising to the west).
- Source area 2 poses no risk to the site due to topography (see Figure 2).

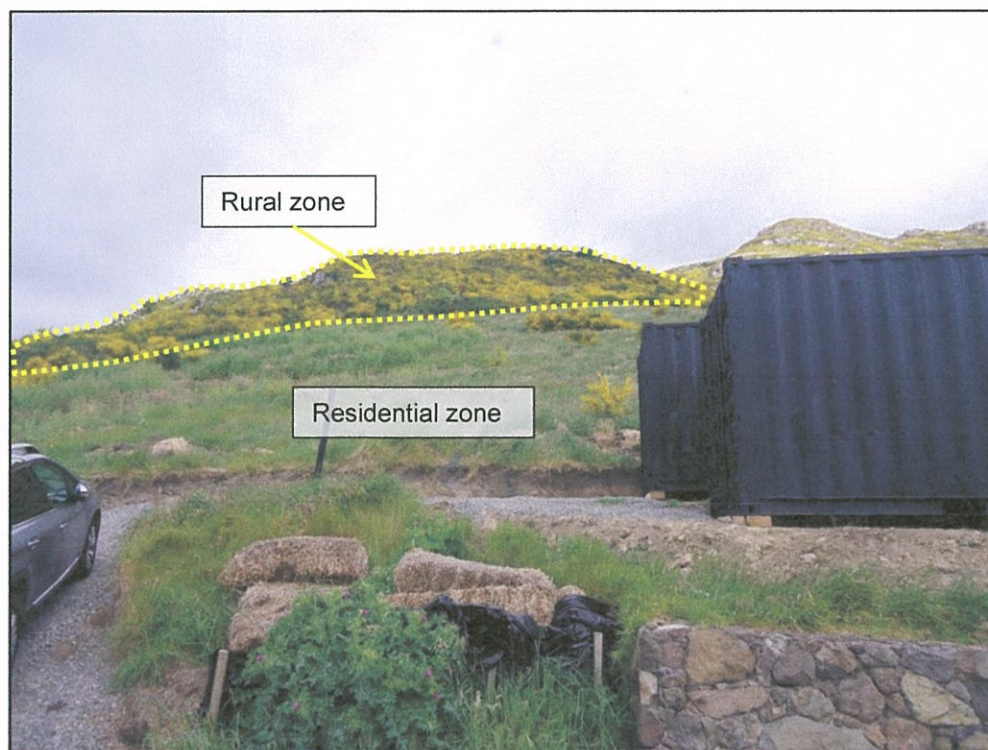
Photograph 1: Looking west to the crest of the slope through the site.

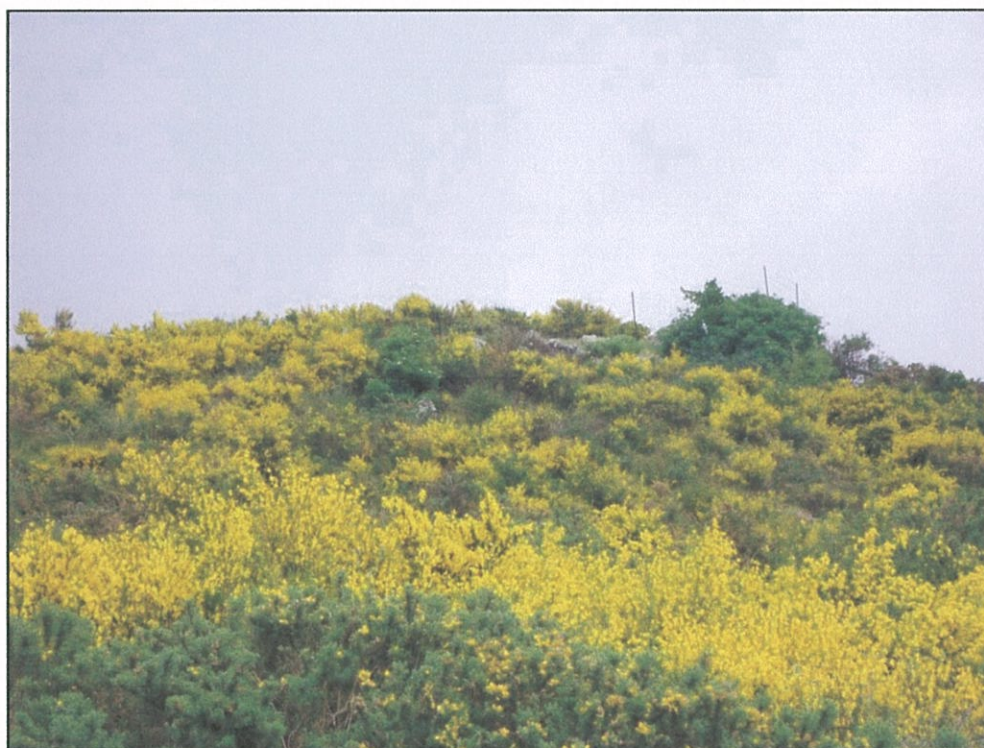
Photograph 2: Looking west up to the crest of the slope and source area 1.

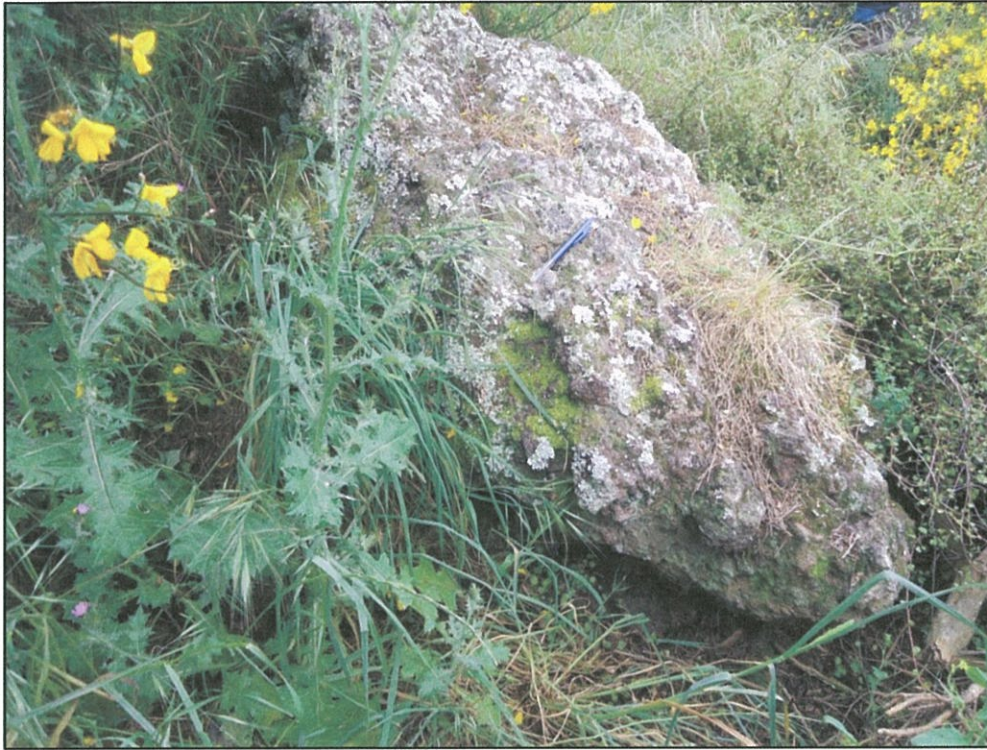
The source area 1 rock is considered to be intact and at very low risk of rolling into the site. Historic boulders on the steeper part of the rural zone were observed to be well embedded into the slope.

Photograph 3: Historic boulder near the crest of the slope – well embedded and very low risk.

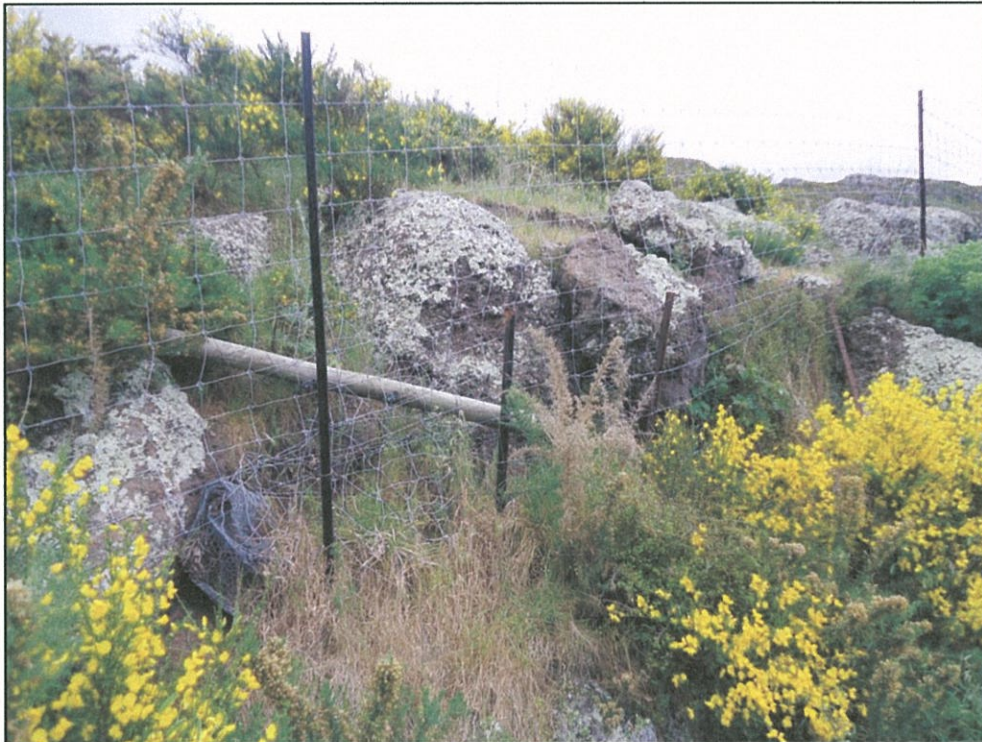
Photograph 4: Source area 1 – Intact, well embedded in-situ rock.
