**BEFORE THE CHRISTCHURCH REPLACEMENT
DISTRICT PLAN INDEPENDENT HEARINGS PANEL**

IN THE MATTER of the Natural Hazards
Proposal

**THIRD SUPPLEMENTARY STATEMENT OF EVIDENCE OF IRIS BROOKLAND
ON BEHALF OF CHRISTCHURCH CITY COUNCIL**

18 MARCH 2015

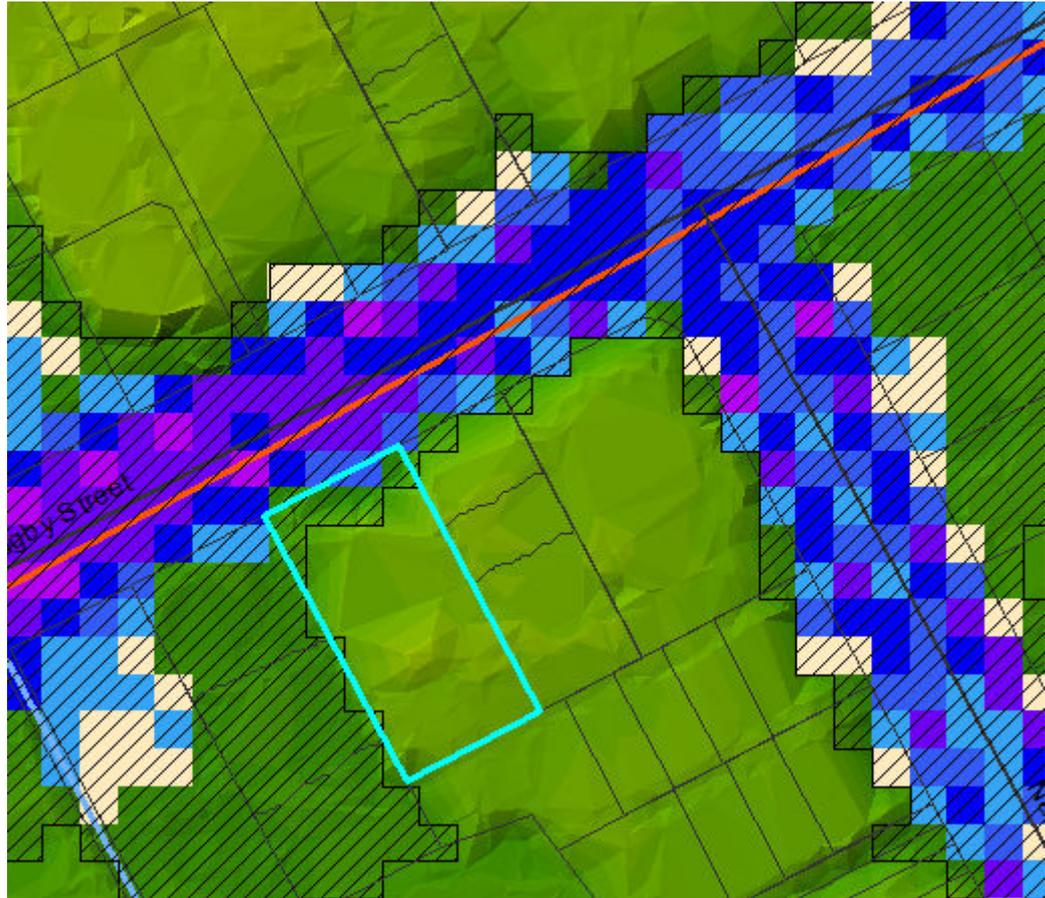
- 3.1** The delineation of the FLFMA for 22 Rugby Street is based on predicted 1/200 year flooding generated by the Dudley Creek model as shown in Figure 1 below. The predicted flood level is 18.14 m RL in Christchurch Drainage Datum. The rain on grid model shows also flooding in this location. The Council has received flood complaints for several events for the corner of Rugby Street and Naseby Street.

Figure 1: Modelled Flood 1/200 Year Extent (blue and purple) and FLFMA (hashed black)

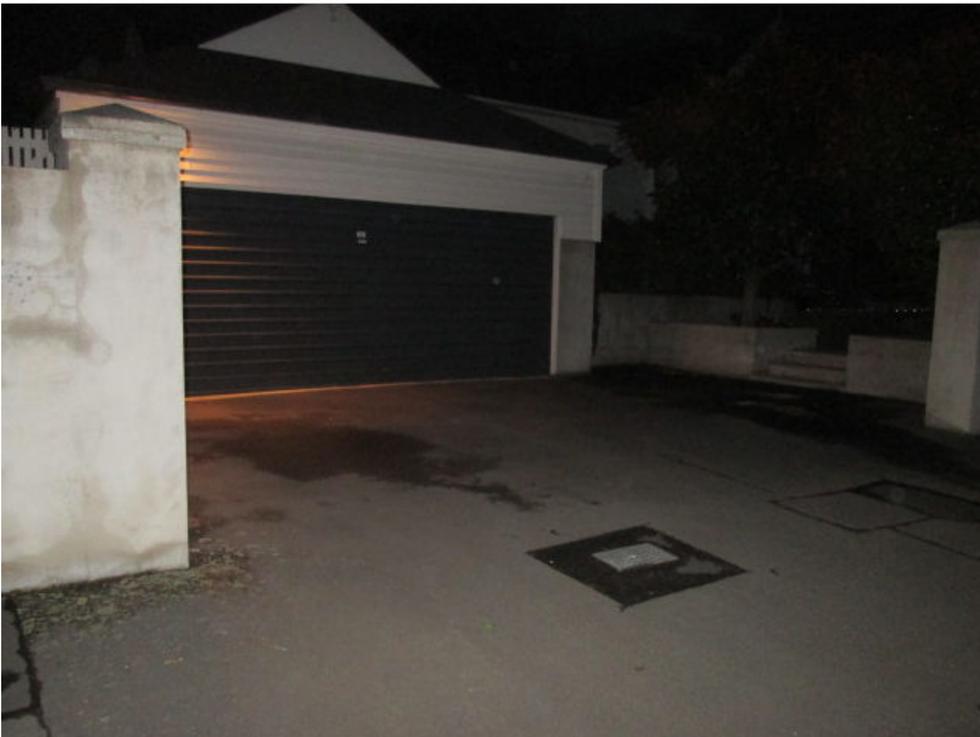
m RL and 18.15 m RL. It is likely that the driveway would be inundated at a water level of 18.14 m RL.

Figure 3: Footpath and Driveway (note the flat slope compared to the retaining wall in background)

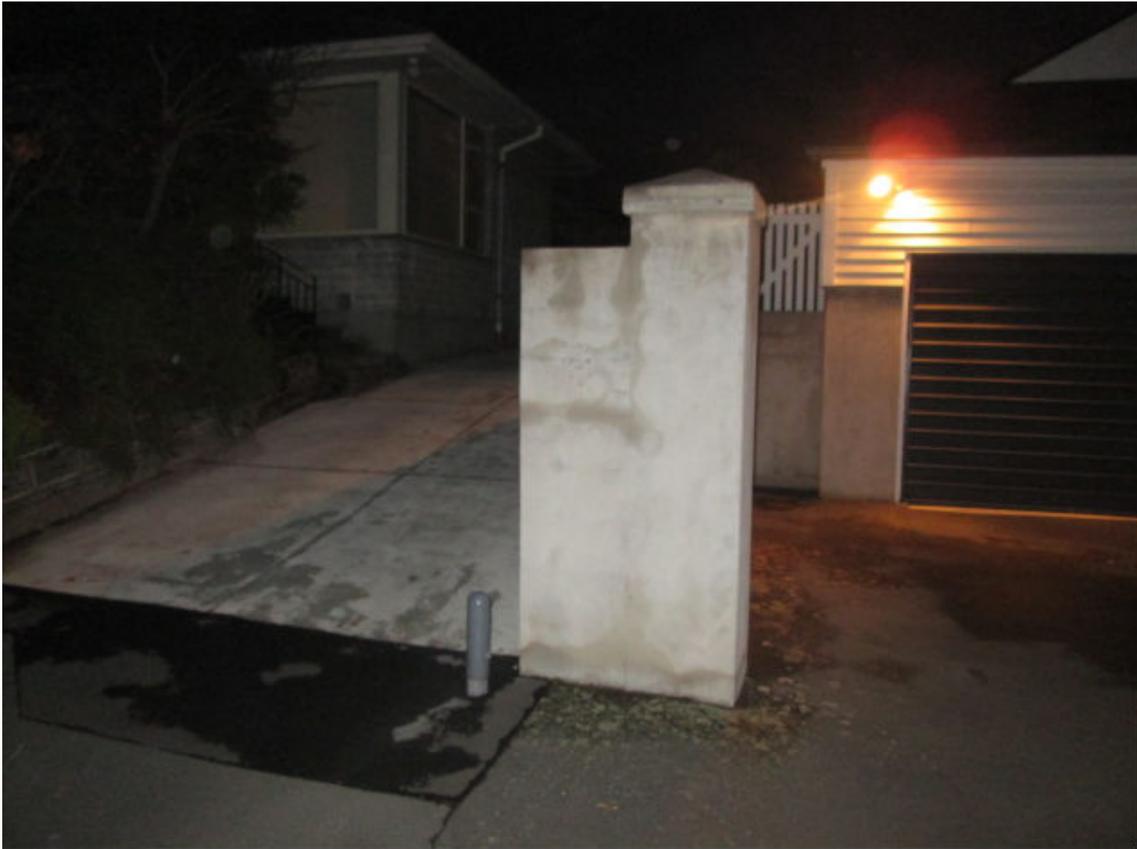
Figure 4: Driveways of 26 Rugby Street (left) and 22 Rugby Street (right)

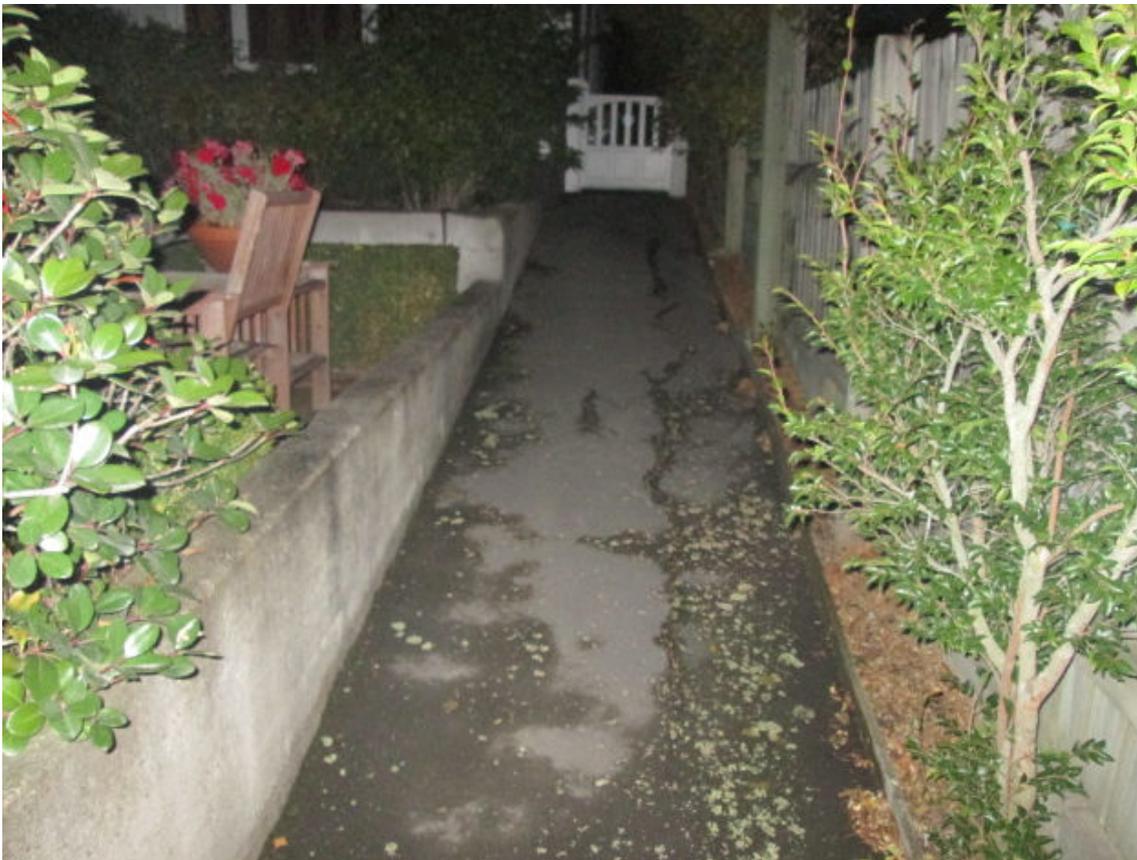
Figure 5: Access Path (also low lying) along Boundary Fence to 20 Rugby Street
